JAMES MIERTSCHIN & ASSOCIATES, INC.
ENVIRONMENTAL ENGINEERING
P.O. BOX 162305 ◦ AUSTIN, TEXAS 78716-2305 ◦ (512) 327-2708

RE: Application of WMARSS for TPDES Permit No. WQ0014782001
Location of Change in Channel Substrate on Bullhide Creek

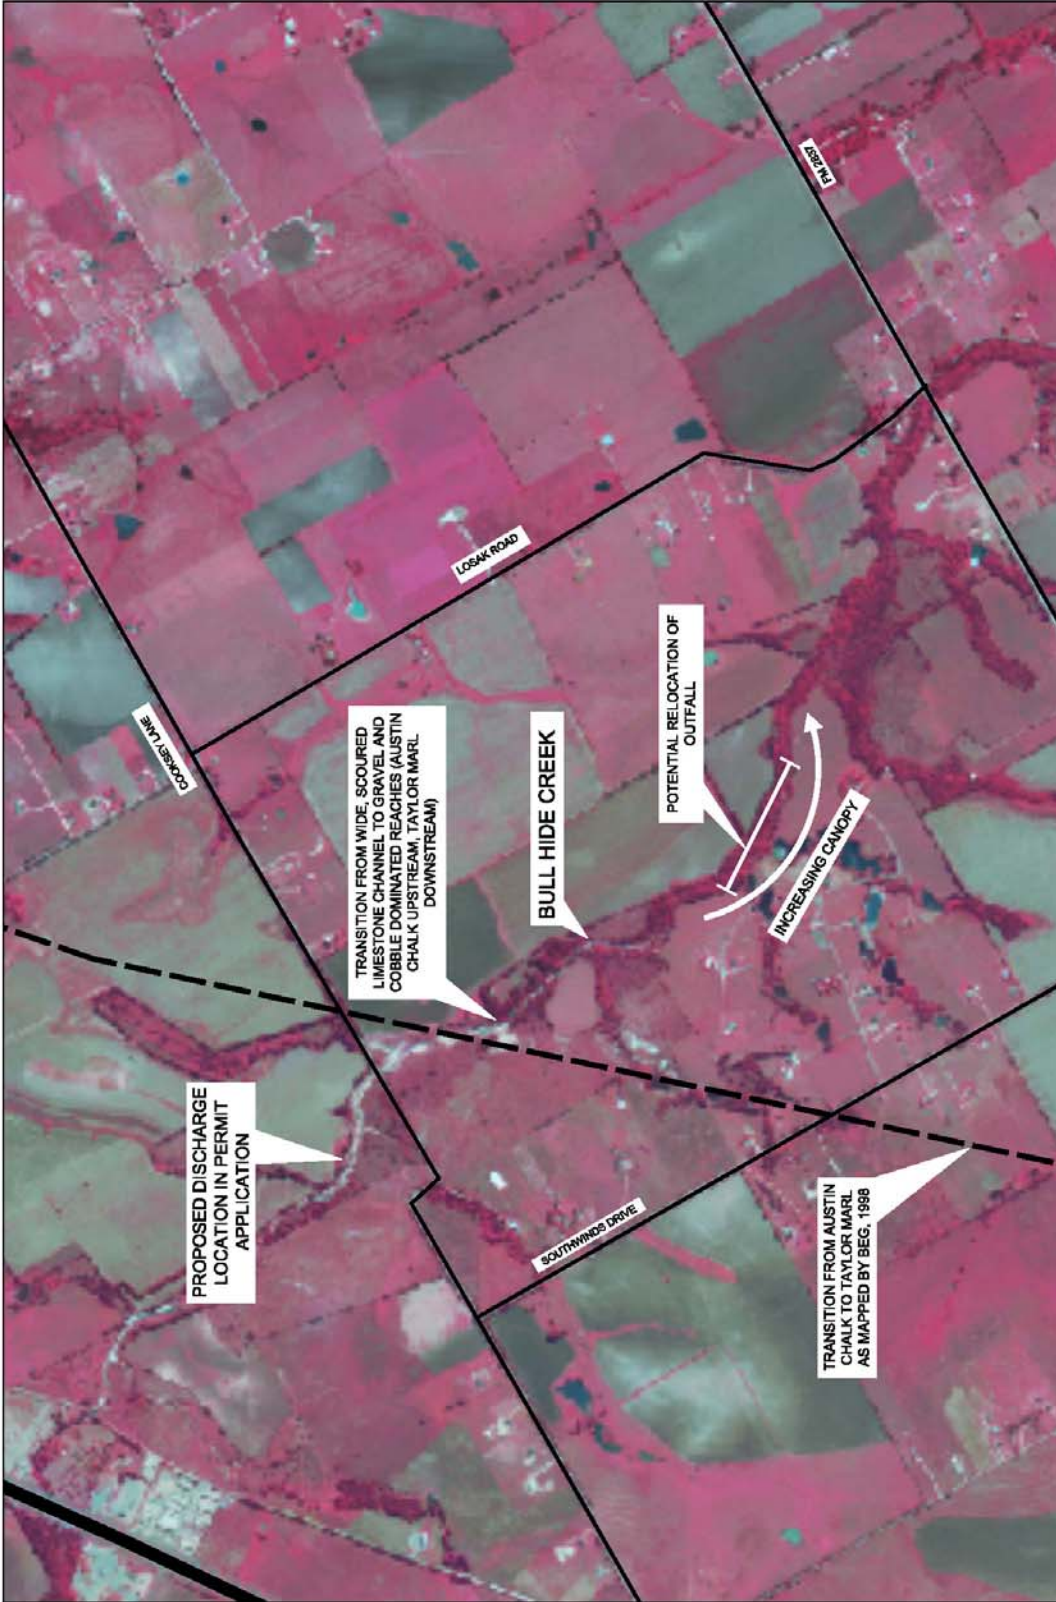
FIGURE 1:
 TRANSITION OF CHANNEL SUBSTRATE

The TCEQ has asked for more information concerning the reach of Bullhide Creek downstream of the proposed point of discharge, with the area of interest roughly the reach between Cooksey Lane on the upstream end and FM 2837 on the downstream end. A survey was conducted on 3 January 2008 in order to examine the transition from the wide, scoured limestone channel evident at the Cooksey Lane crossing to the gravel and cobble dominated substrate that is typical of downstream reaches.

The University of Texas Bureau of Economic Geology (BEG) has published mapping that provides an indication of where the transition should be expected (Proctor, et al, 1998, Geologic Atlas of Texas, Waco Sheet). The BEG mapping shows a transition from the Austin Chalk limestone group to the lower Taylor marl of the Ozan Formation just downstream of Cooksey Lane, as shown on the attached Figure 1. The field survey of 3 January 2008 verified the accuracy of this transition location, also as noted on Figure 1. From the Cooksey Lane bridge, Bullhide Creek exhibits a wide (25-35 m), bare rock (Austin Chalk limestone) channel that extends about 375 m downstream to the vicinity of the Smith Farm outbuildings, ending abruptly at a large outcrop on the right bank (see Figure 2). This is clearly where Bullhide Creek crosses the contact between the Austin Chalk and the Taylor Marl. Downstream of this contact point, the "limestone" would be generally described as crumbly, calcareous clay and marl.

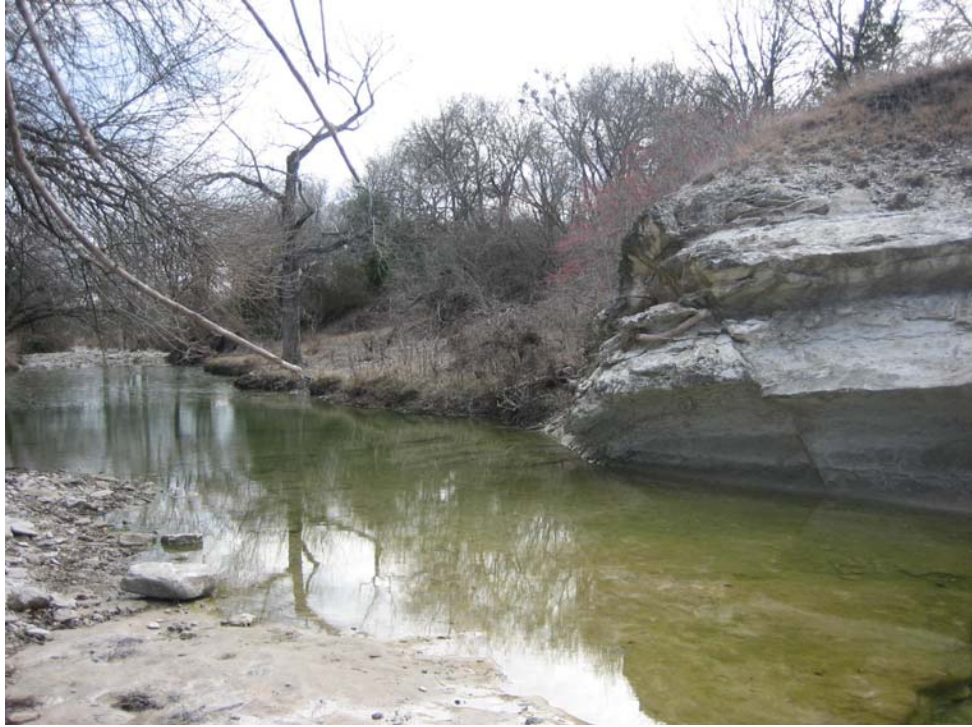
Outcrop on right bank, looking down stream

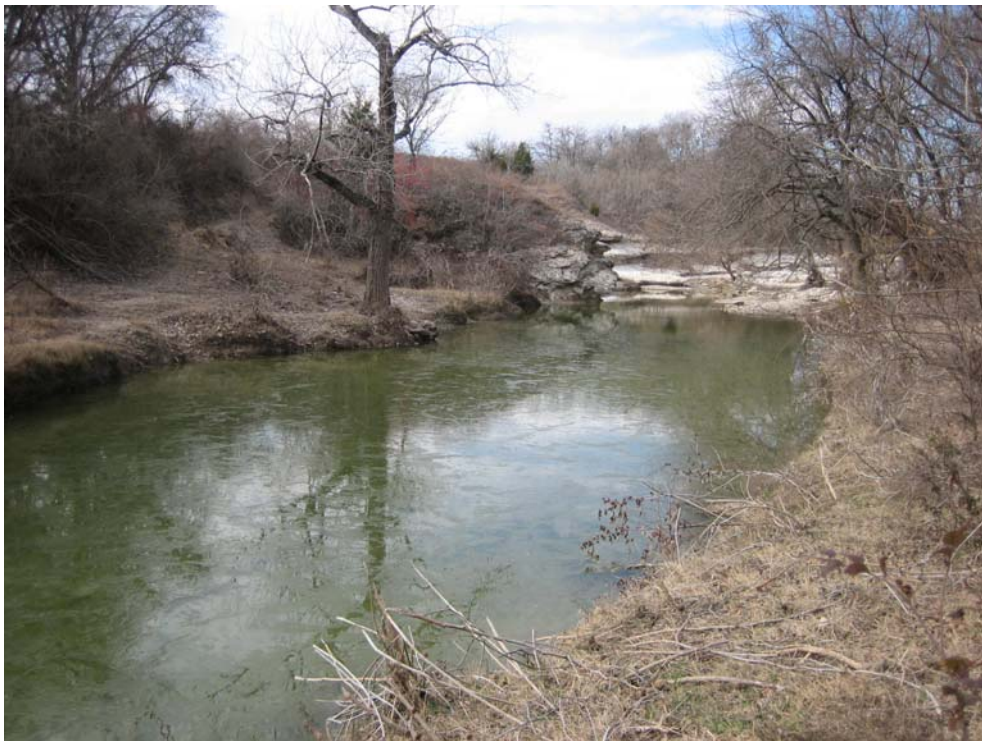
Figure 2: Transition Point

Looking upstream

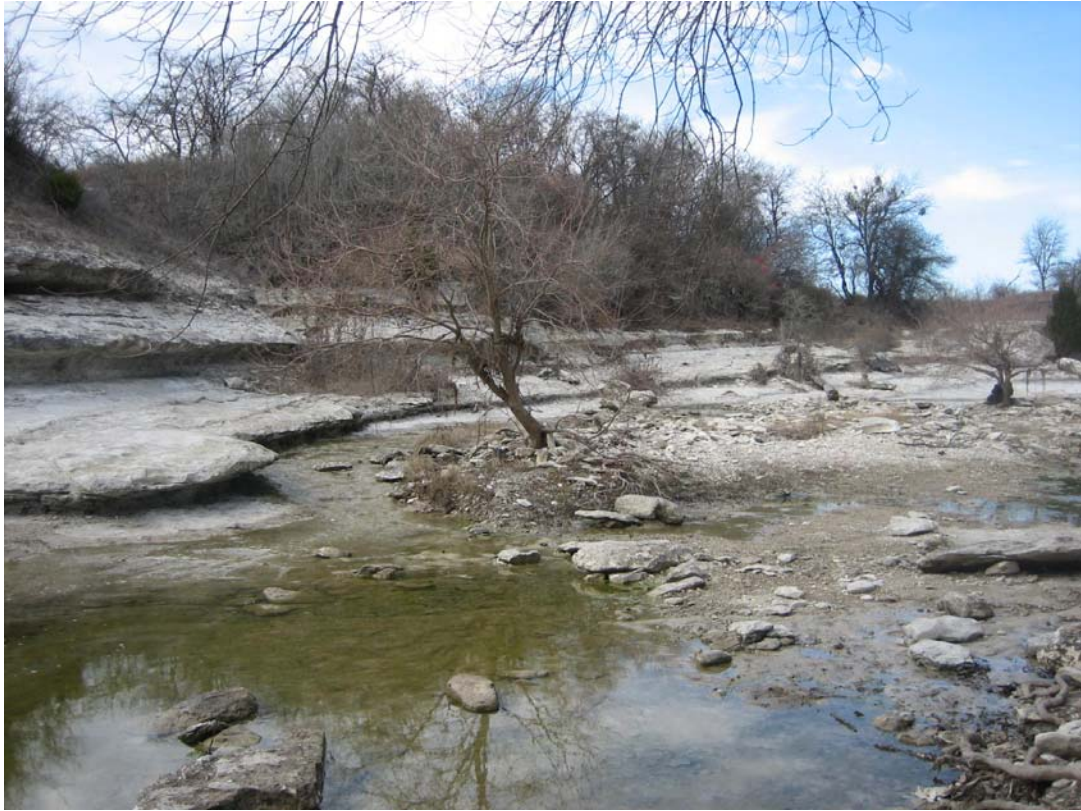
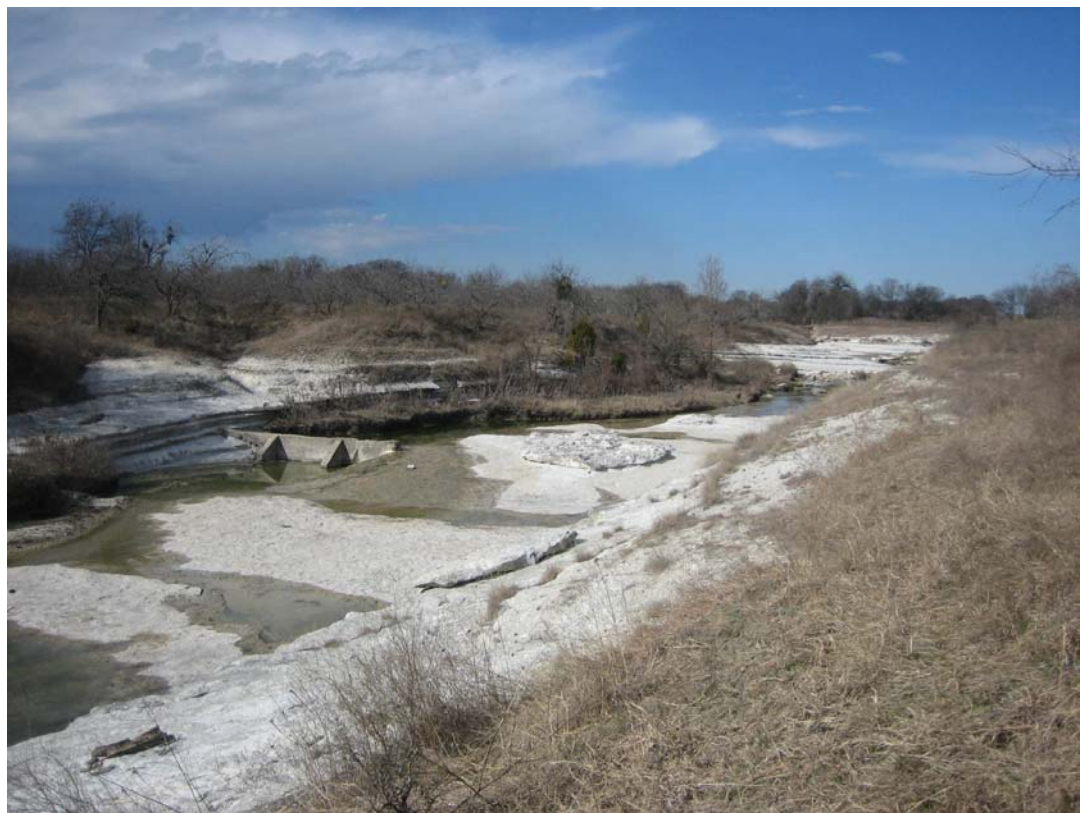
Where Bullhide Creek is underlain by the Austin Chalk, the channel is extensively scoured and sculpted, reflecting the varying hardness of the limestone layers. The channel section is a shallow U-shape with multiple ledges, channels and shallow potholes common (see Figure 3). Bullhide Creek in this reach is incised 5-7 m into the surrounding prairie landscape. This larger channel tends to become narrower and more sharply defined in the downstream direction.

With respect to channel morphology, the limestone bedrock of the Austin Chalk exhibits the development of erosional features, such as parallel multiple channels, scour holes and a distinctly stair-step channel profile, that are common in the limestone beds of Edwards Plateau streams. While this erosional sculpturing appears to be present in the Bullhide Creek channel upstream of the transition area, relatively little channel irregularity is evident downstream in the Taylor Marl. The softer limestones underlying the reaches of Bullhide, and Cow Bayou as well, appear to have been scoured to a relatively smooth chute, which is facilitating bed load transport and additional scouring of the channel.

Figure 3: Typical Austin Chalk Substrate

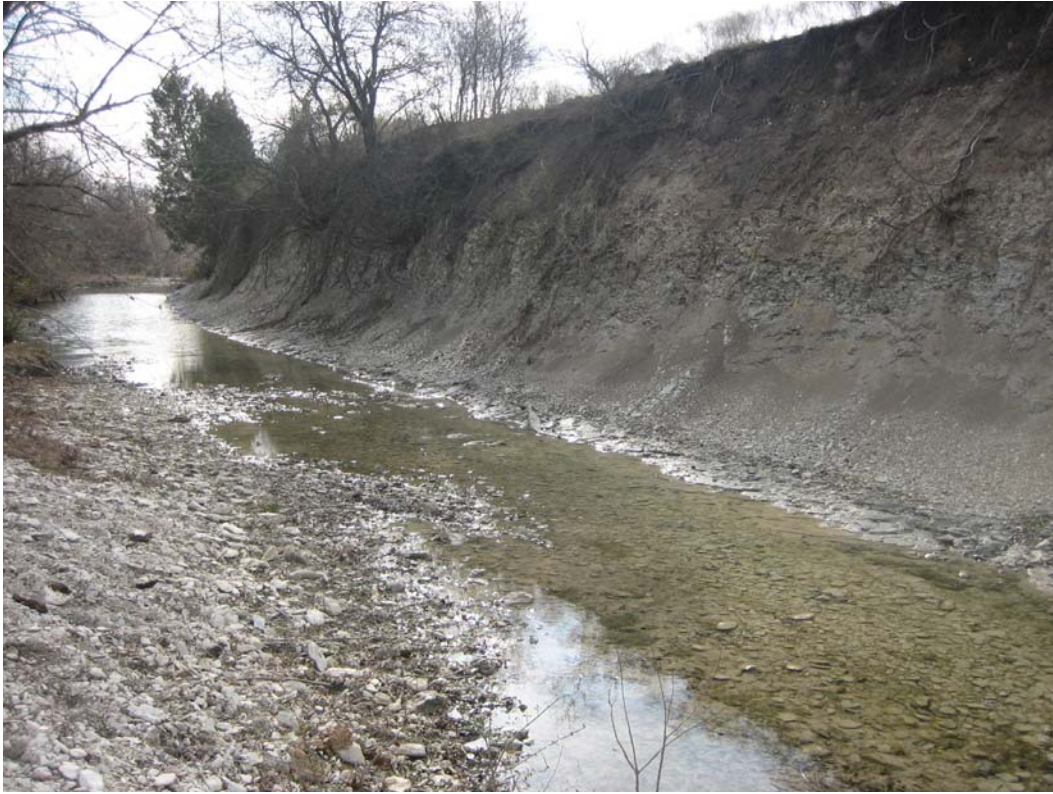
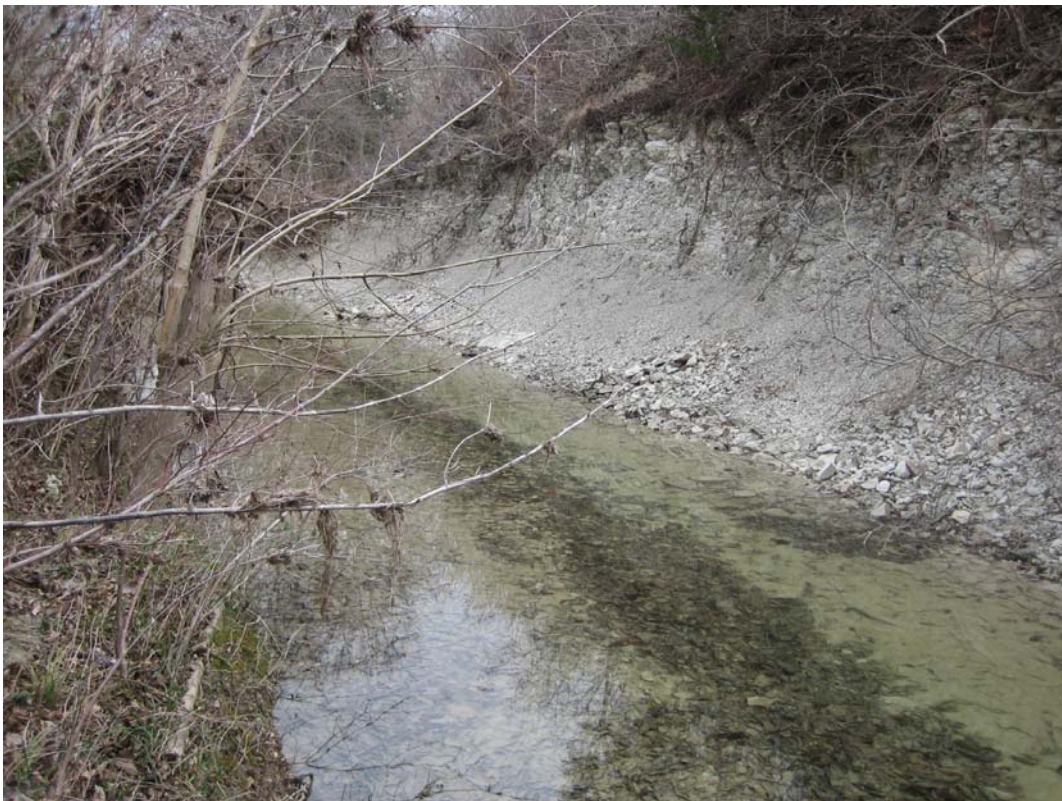
Below the outcrop where the massive limestone exposed in the upper stream reach ends, the channel exhibits bluff banks consisting of soils and Taylor Marl (Ozan formation), a weakly indurated, crumbly material that is actively eroding (see Figure 4). The stream bed tends to be smoothly scoured, reflecting the relative softness of the bedrock, and

partially covered by sheets and bars of gravel and cobbles imbedded in fine-grained (silt and sand) material. Both the Bullhide and Cow Bayou channels have this appearance throughout the reaches surveyed downstream of FM 2837. The wetted channel is much narrower (2-5 m) in this downstream reach, which meanders only slightly among the irregular gravel bars and vegetated terraces contained within the larger channel.

In the downstream Taylor Marl reach, gravel/cobble/silt coverage of the smooth limestone was estimated at intervals of approximately 10 meters over two longitudinal transects roughly midway between Cooksey Land and FM 2837. On the upper transect, coverage by gravel sheets ranged from 0 to 100% coverage, and averaged 28% (n=11). Downstream, coverage ranged from 5% to 100%, average 72% (n=12).

Figure 4: Typical Marl Substrate

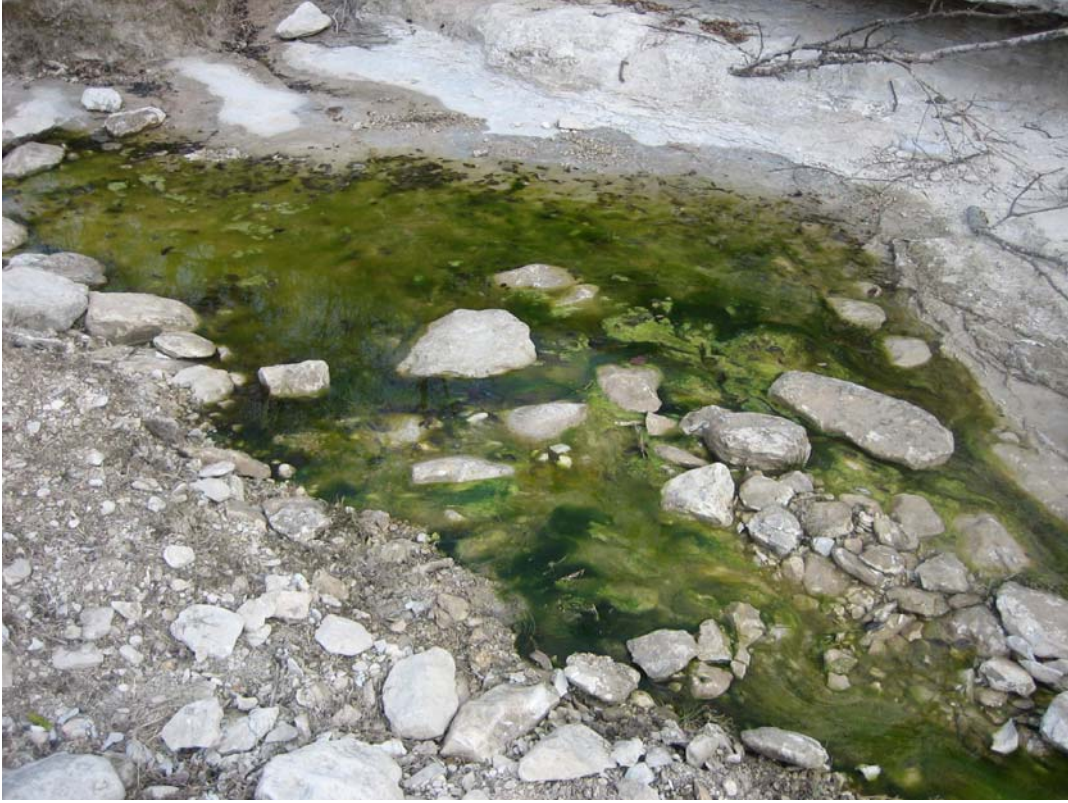
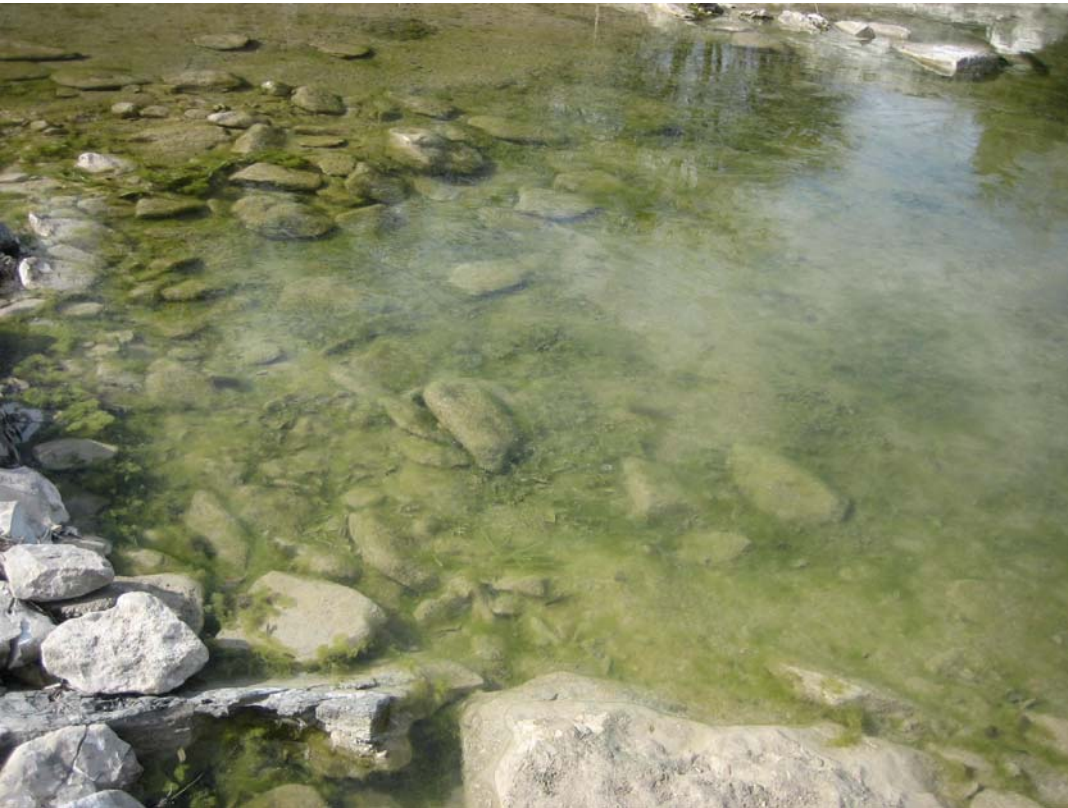
At the time of the 3 January 2008 site visit, benthic algal mat development was observed on the bedrock channel bottom in the Austin Chalk reach (Figure 5), but was most extensive in quiet backwater areas (Figure 5). Downstream of the Austin Chalk Reach into the Taylor Marl, benthic algal growth was evident on riffles, in bedrock pools and in backwater areas, but not to the extent and density seen in the upper 375 m reach between Cooksey Lane and the transition point. This winter growth is facilitated by the lack of shading due to the “leaf off” condition of the riparian corridor. Examination of aerial photography and direct observation indicates that a canopy sufficient to significantly shade the channel during spring, summer, and fall seasons is increasingly present beginning in the vicinity of the transition point where the channel narrows significantly and riparian vegetation has developed on the terraces within the larger channel.

Figure 5: Algal Mats, Austin Chalk Substrate
